Case Study
Arbor Dev. 30 Seneca St. Hornell, NY

Building Performance 20 Large Apartments Envelope Common Areas

Building Performance 20 Large Apartments & Common Areas

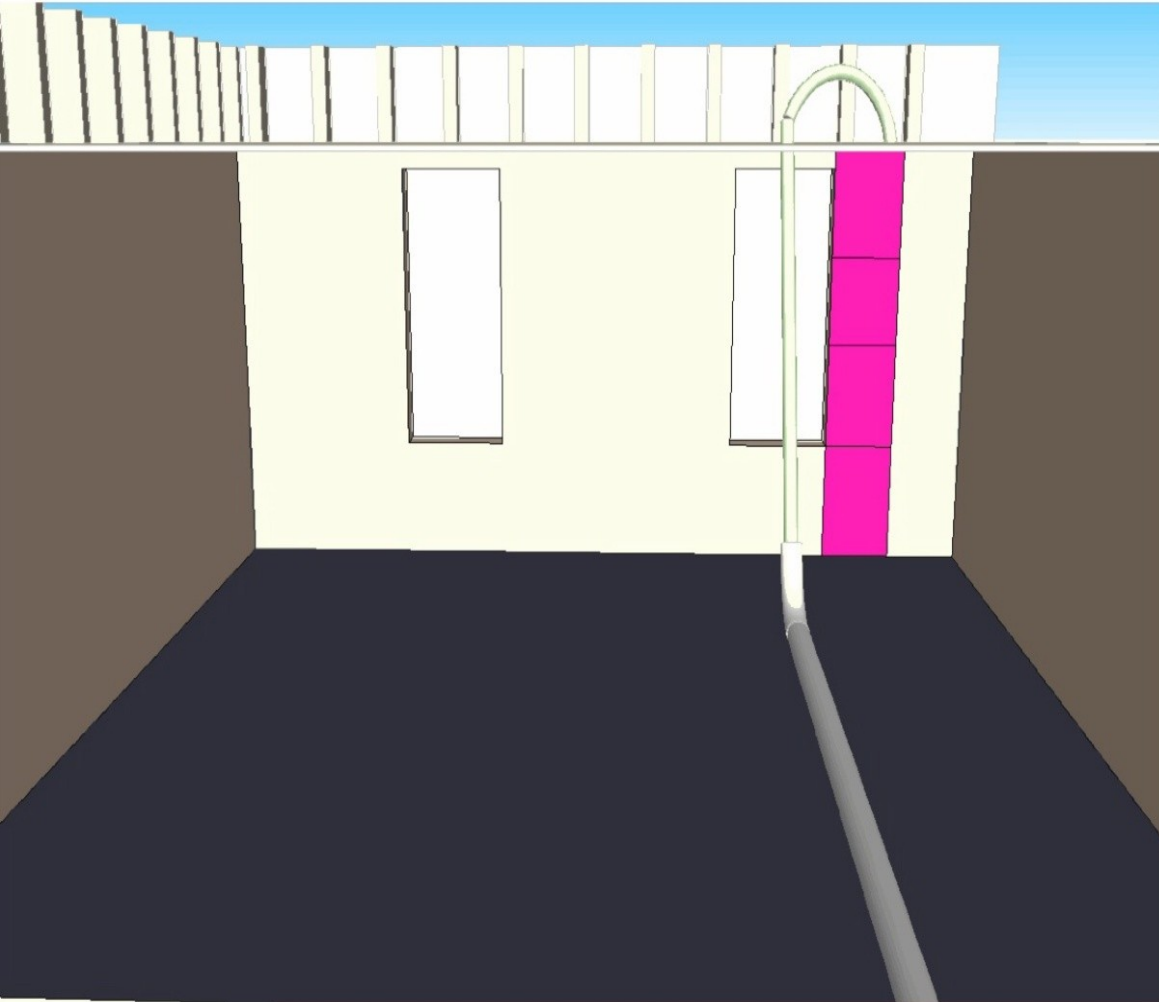
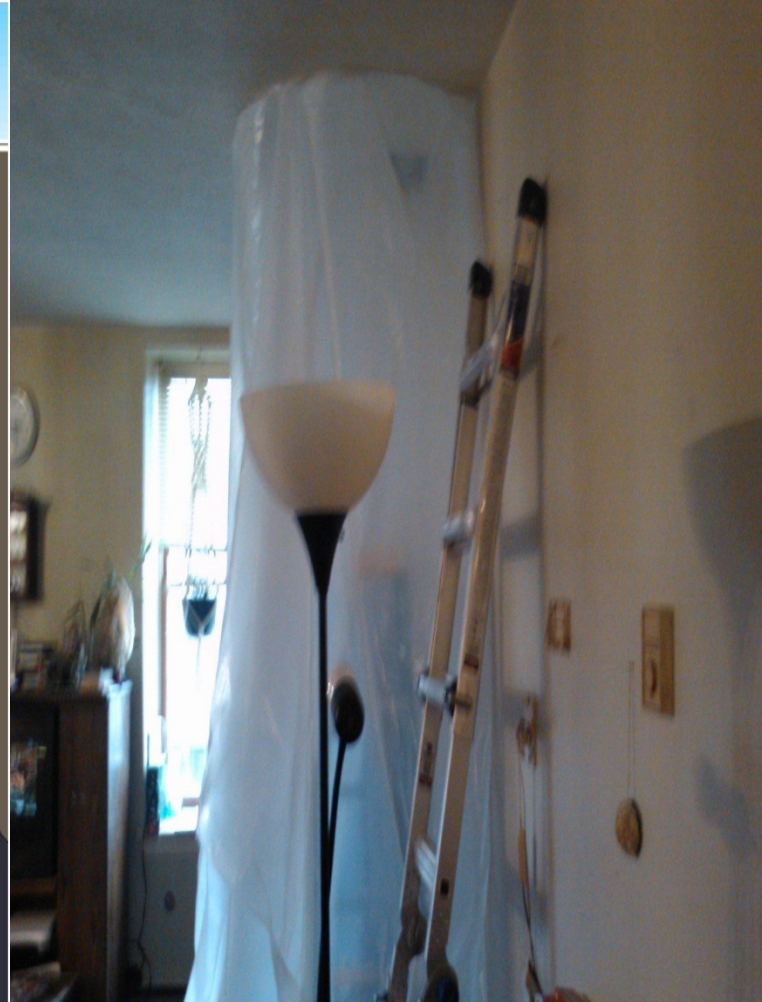
Containment areas were constructed to protect tenants' possessions from dust.

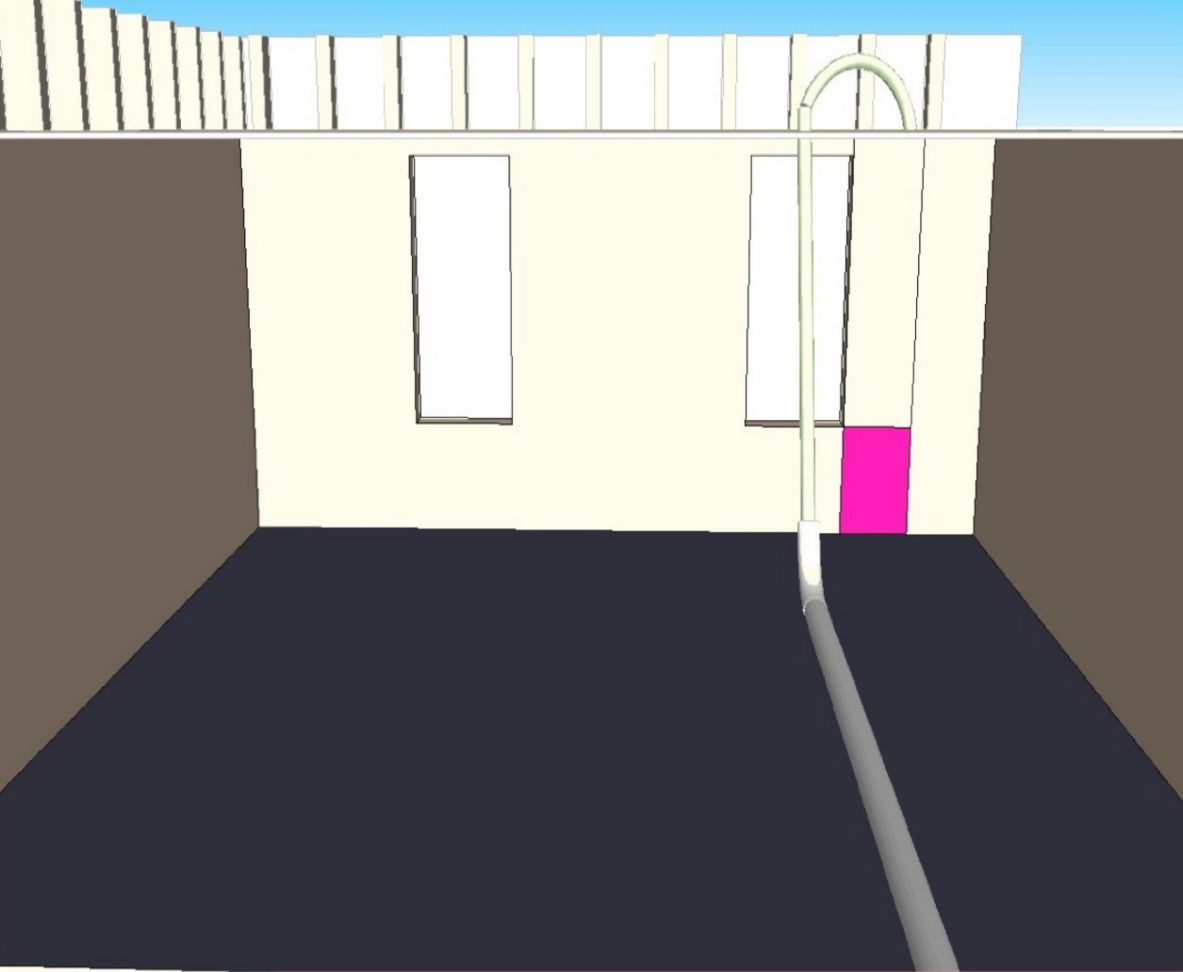
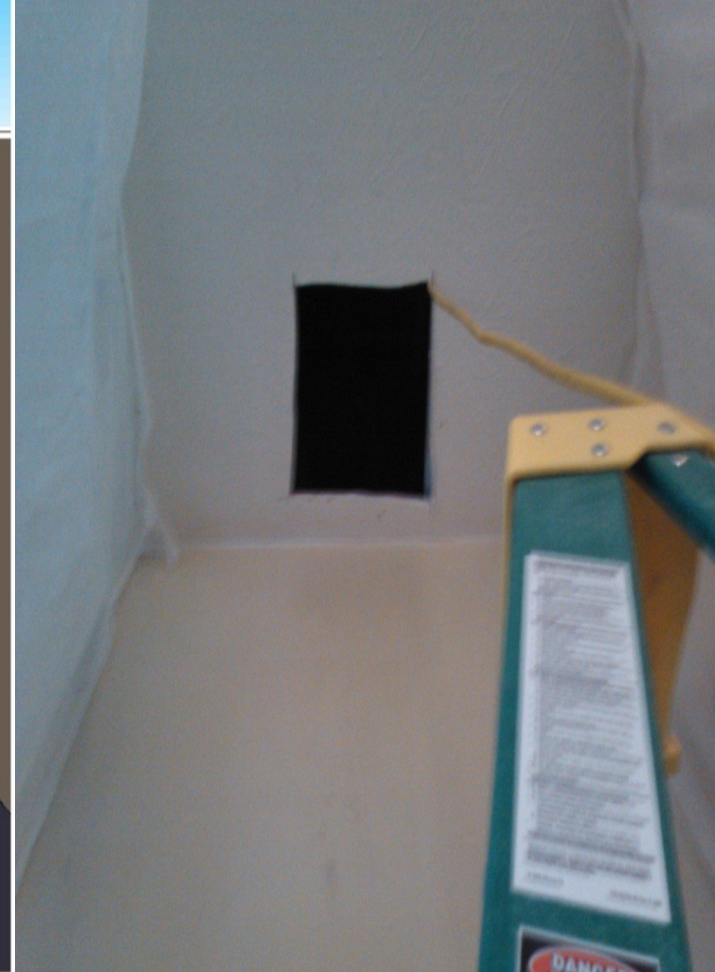
16" x 16" or smaller hole was cut into the ceiling . This was our entrance, and a hose was through the ceiling and down into the wall cavity.

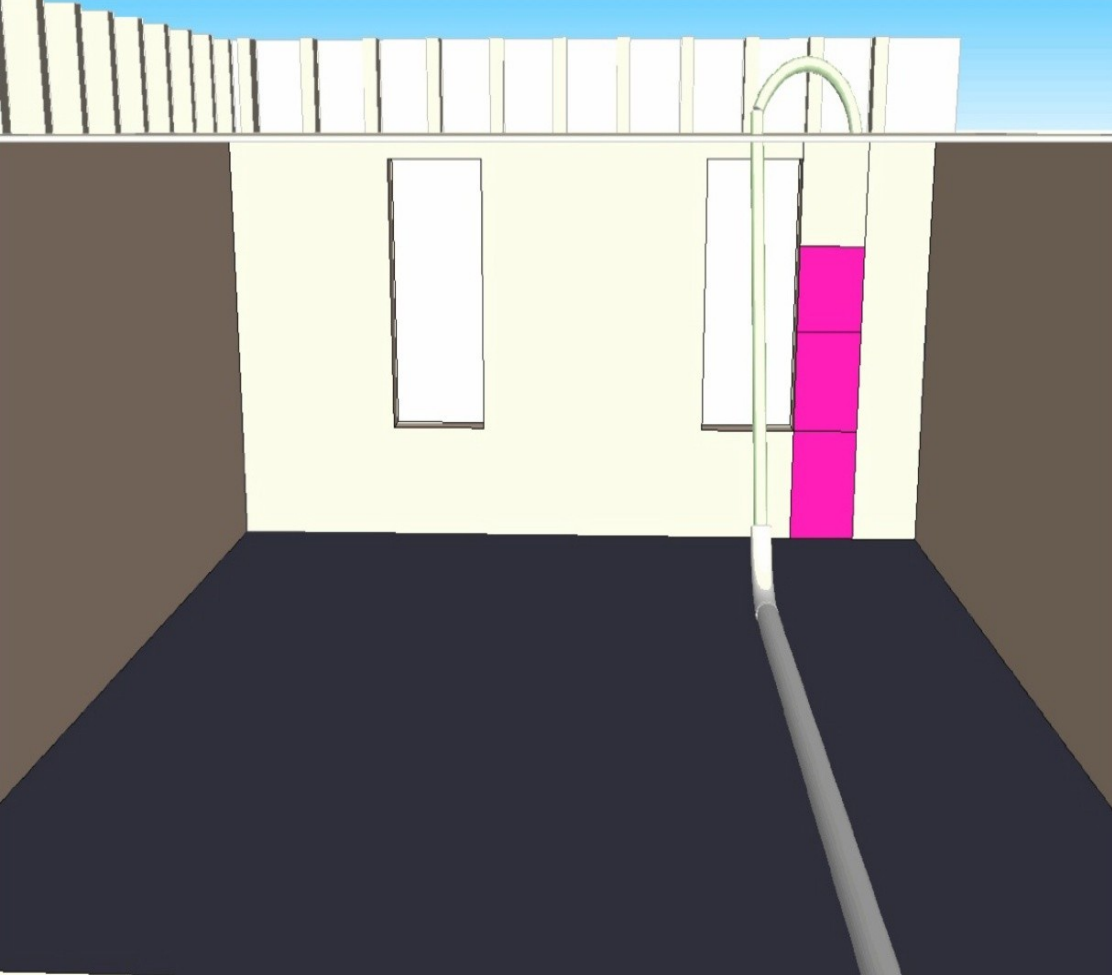
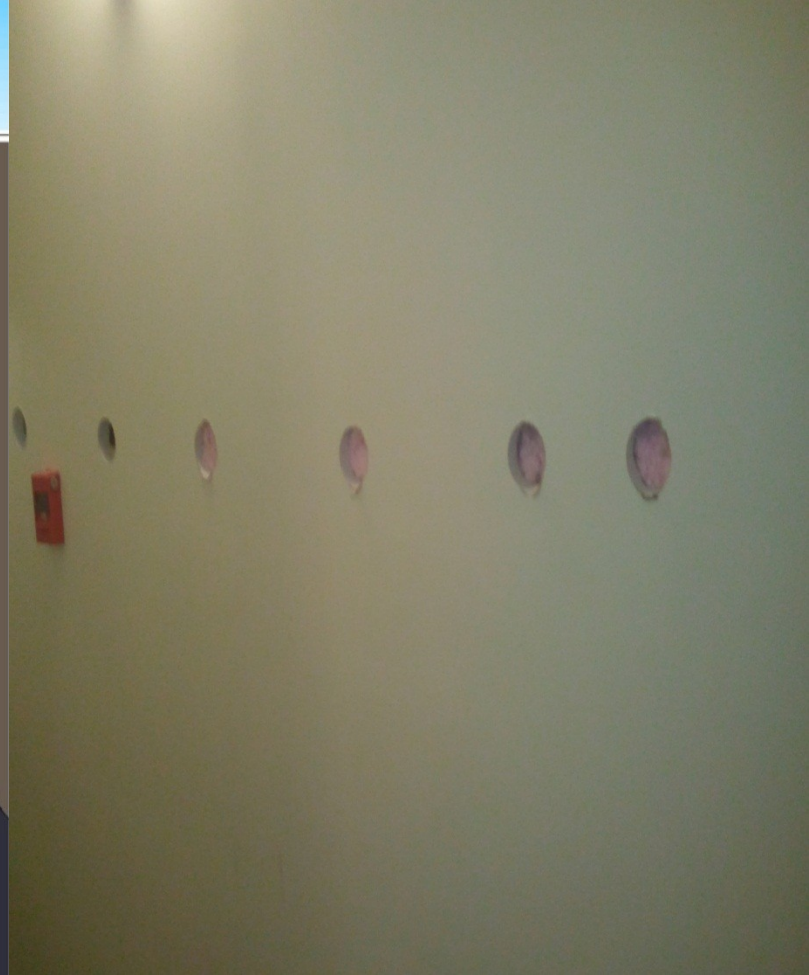
**Access from above was not always feasible,
so 3" holes were drilled into the walls, and
they became our access.**

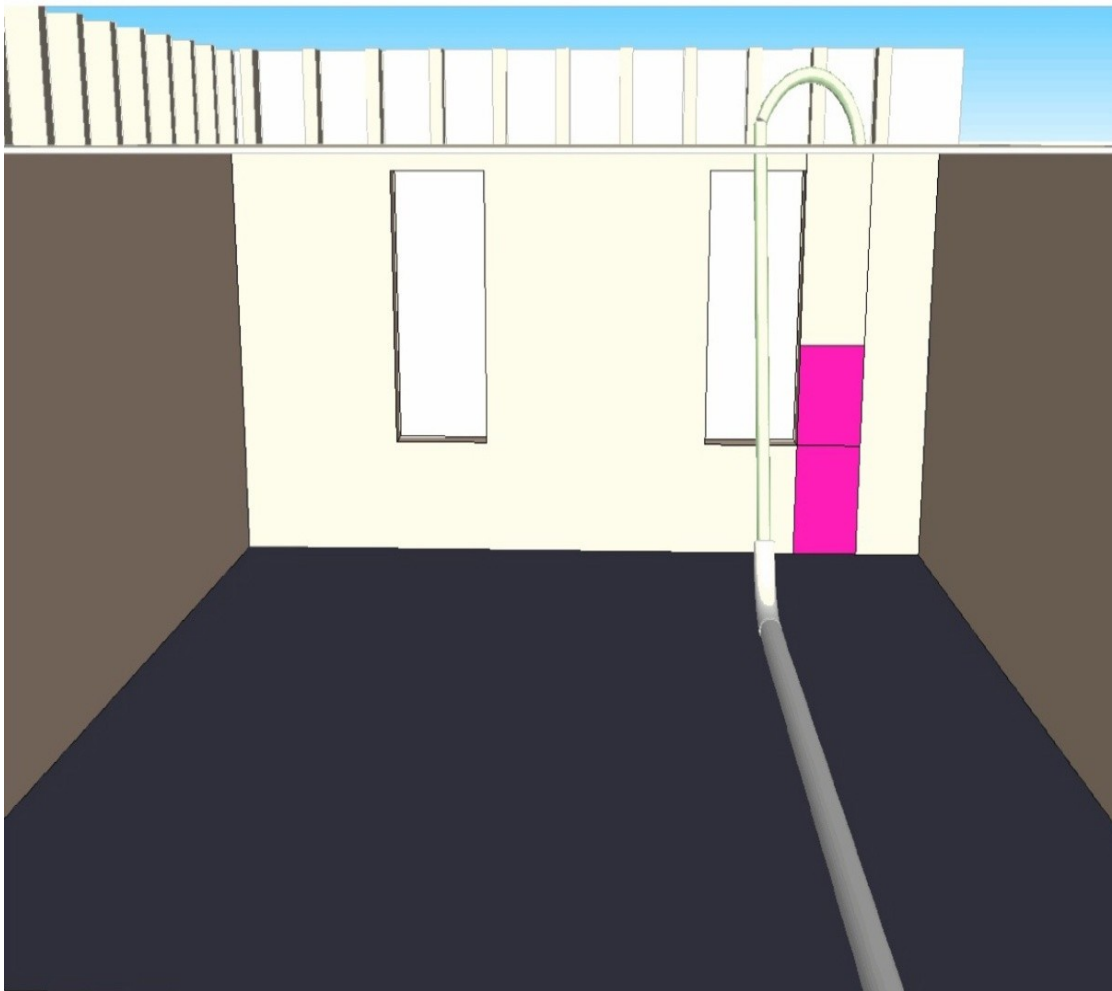
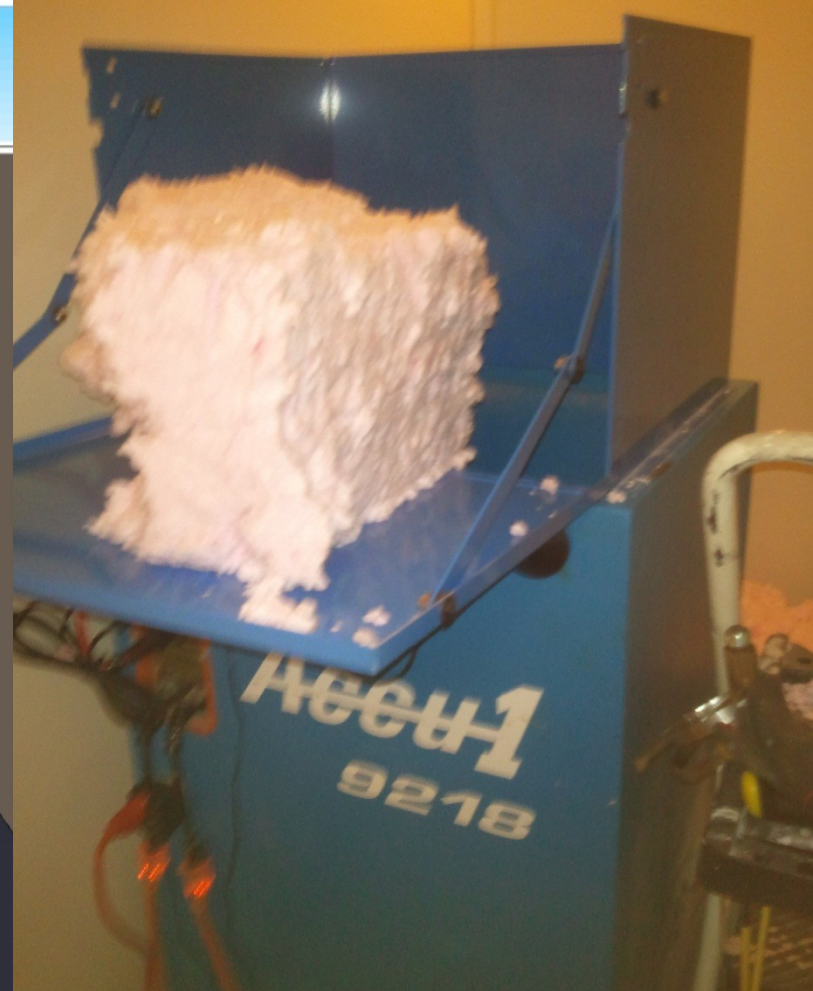
Blown insulation run from the hallway & dense packed into wall cavities.

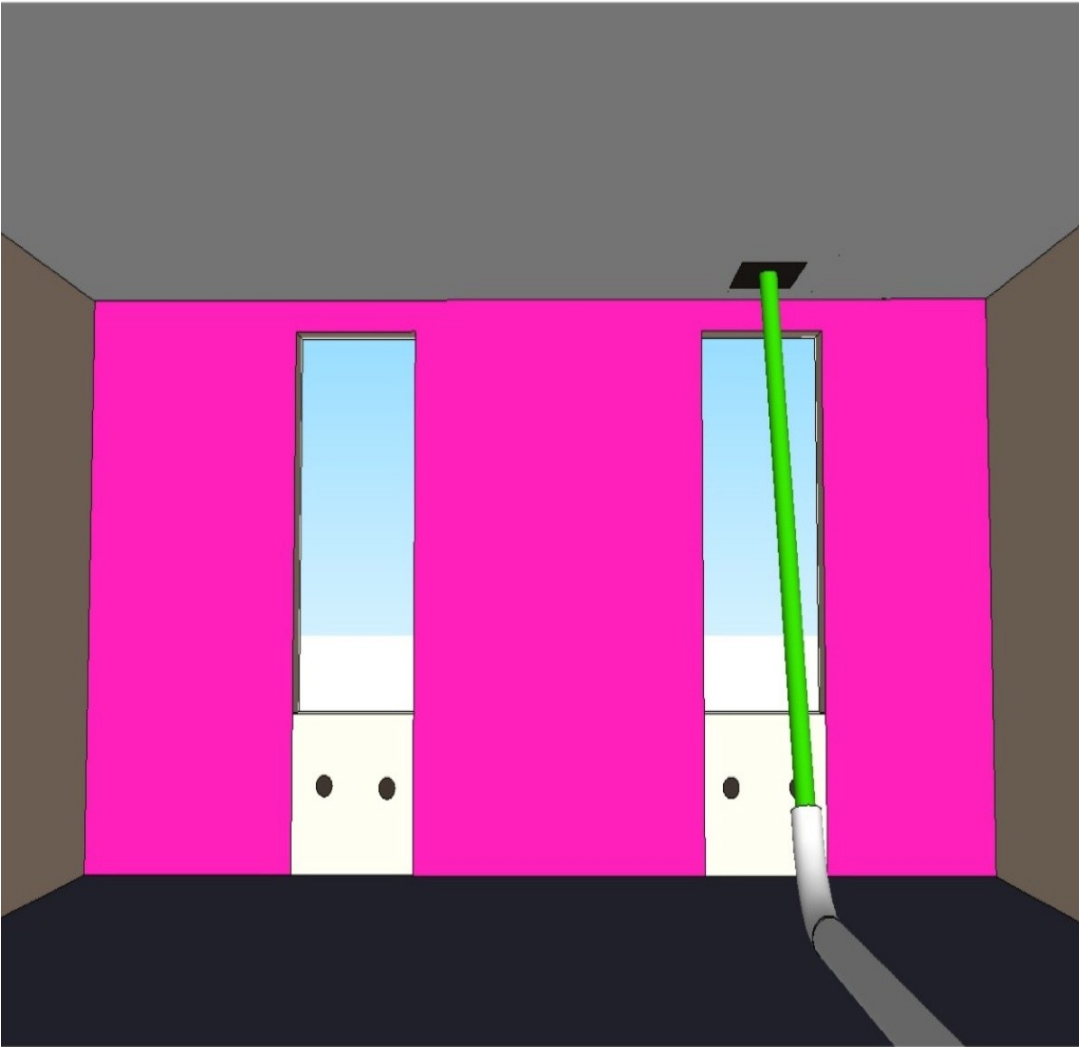
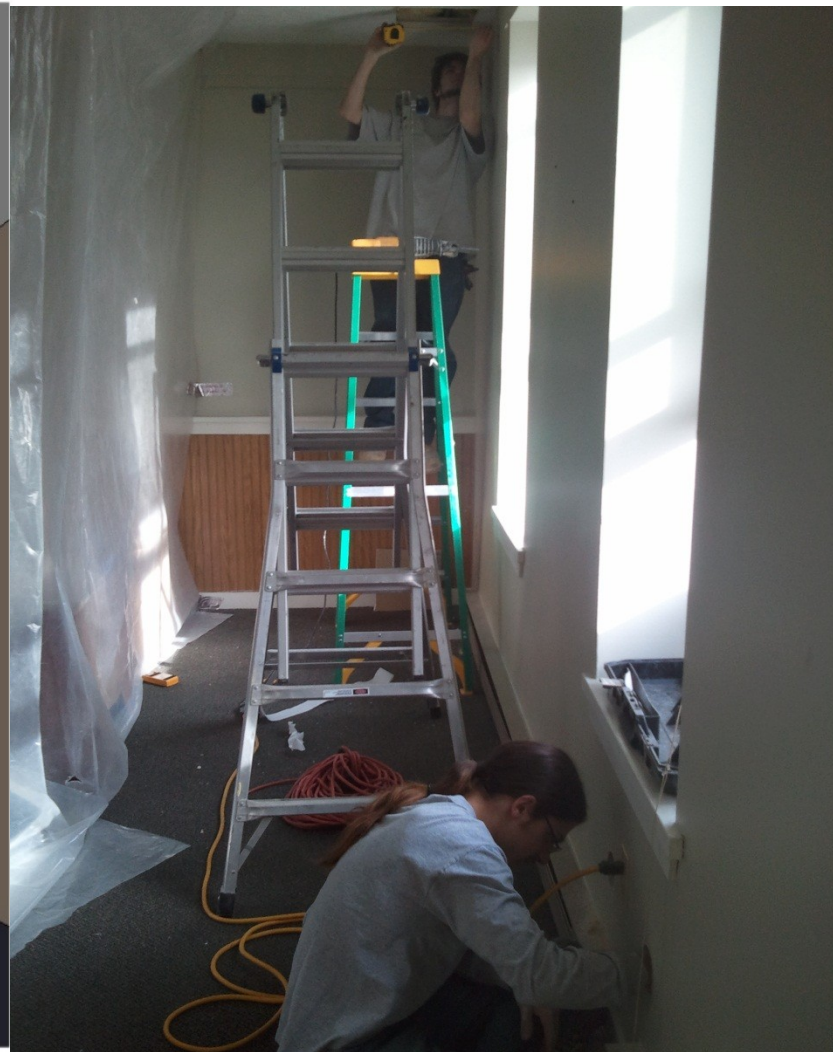
This process was repeated until all cavities were full & dense packed.

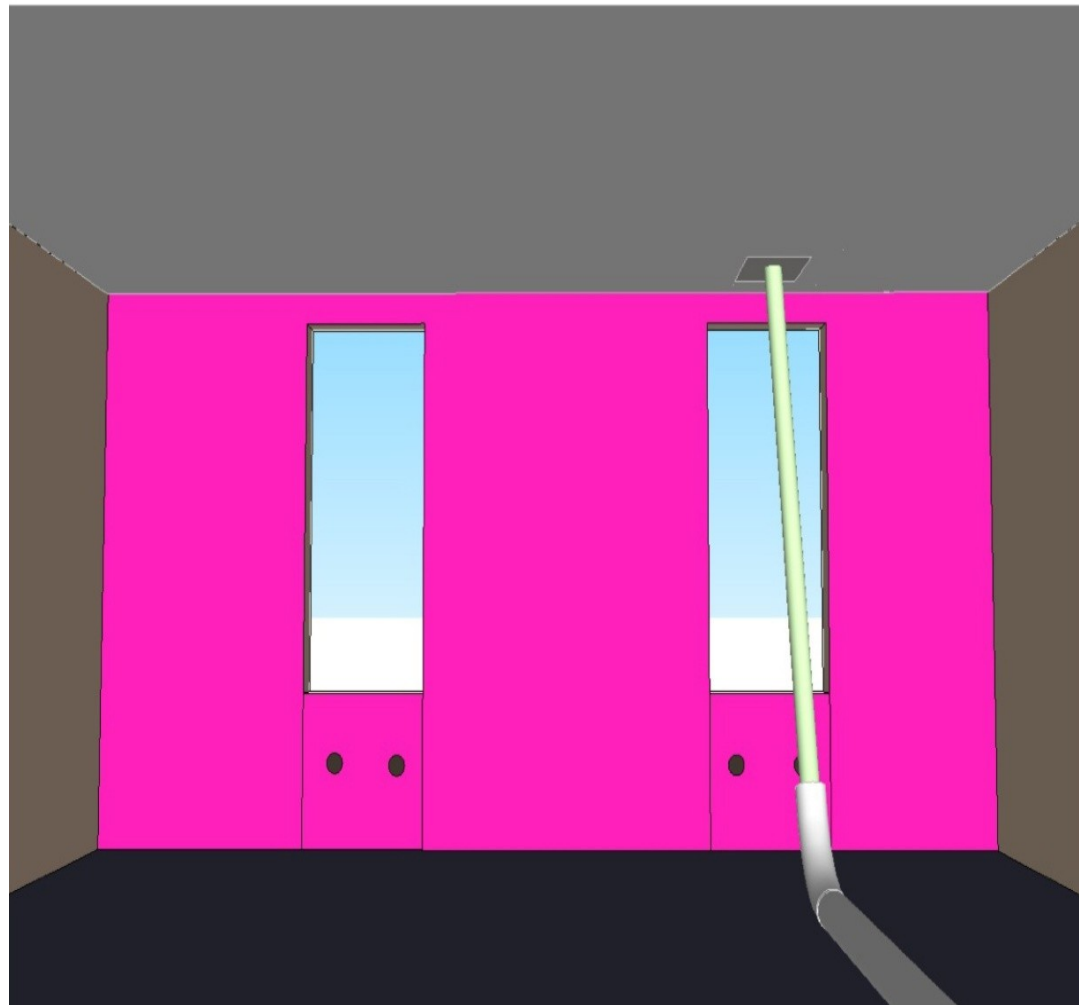
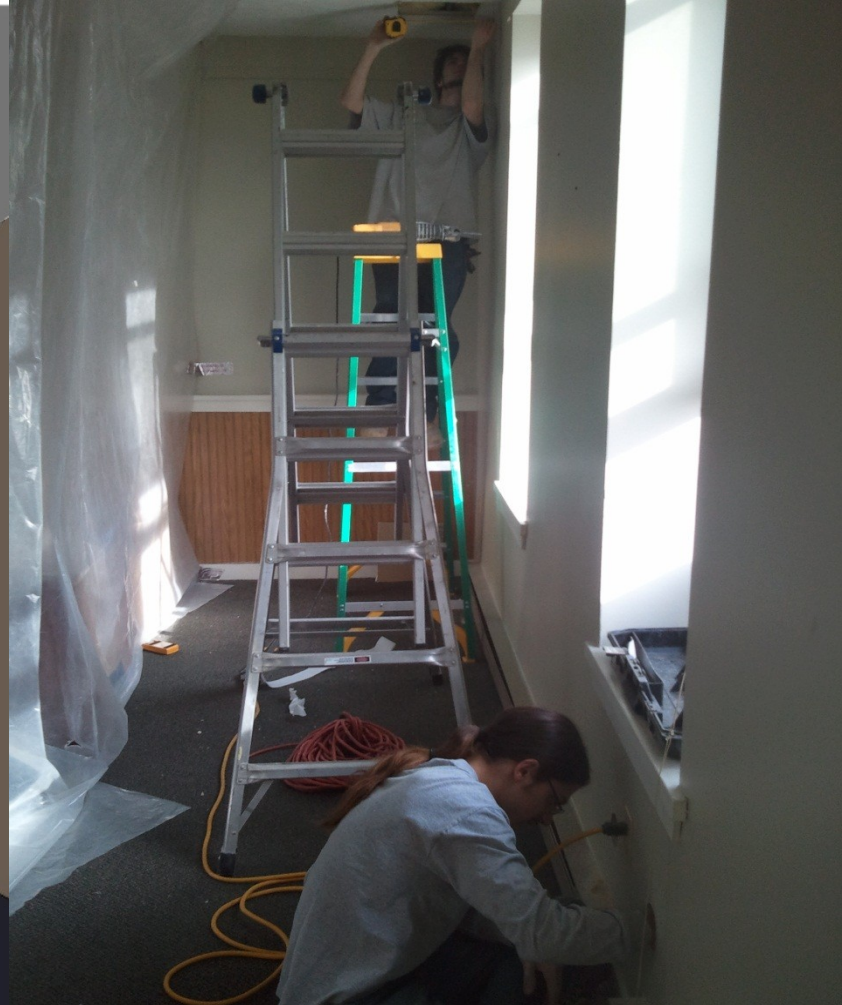
Wall areas beneath windows were dense packed via 3" holes drilled into each cavity.

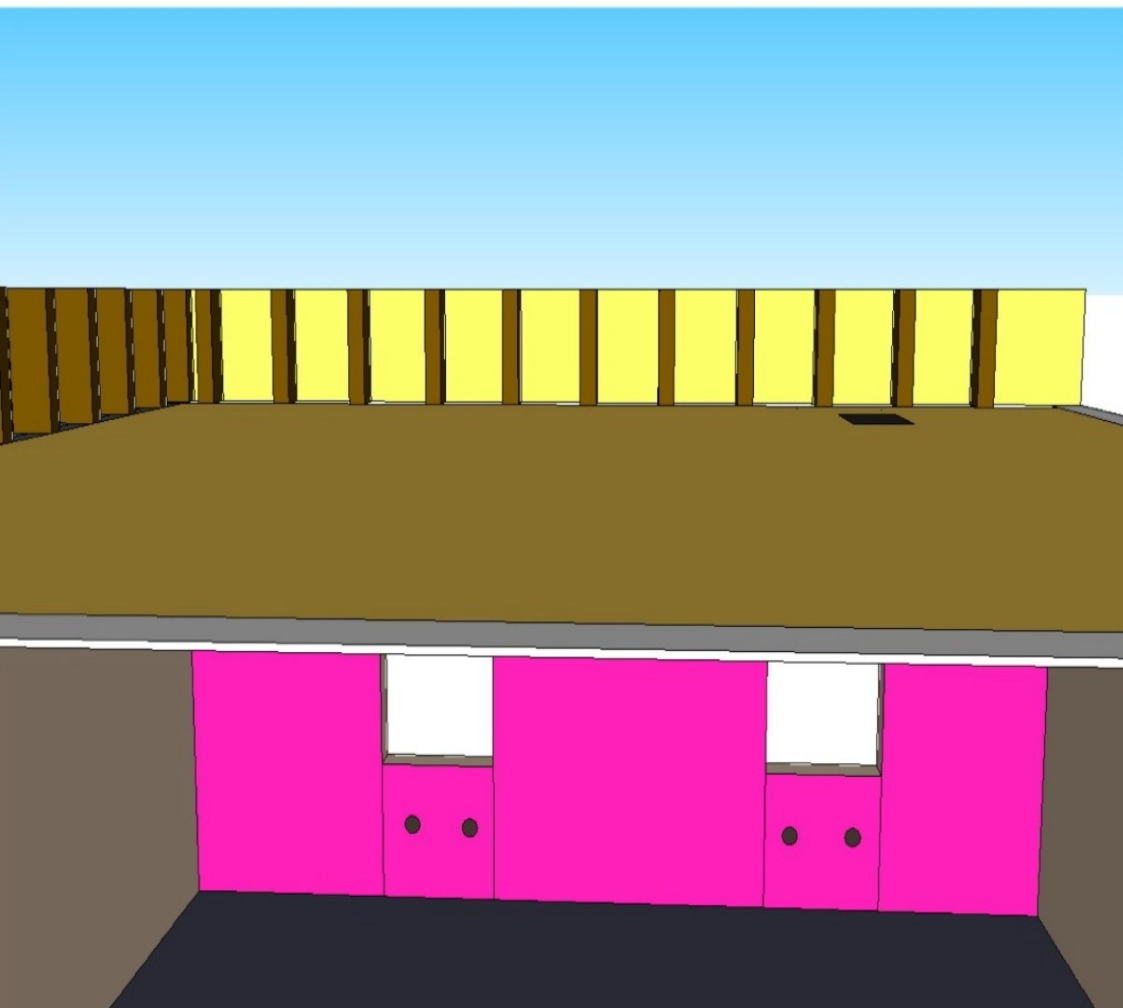
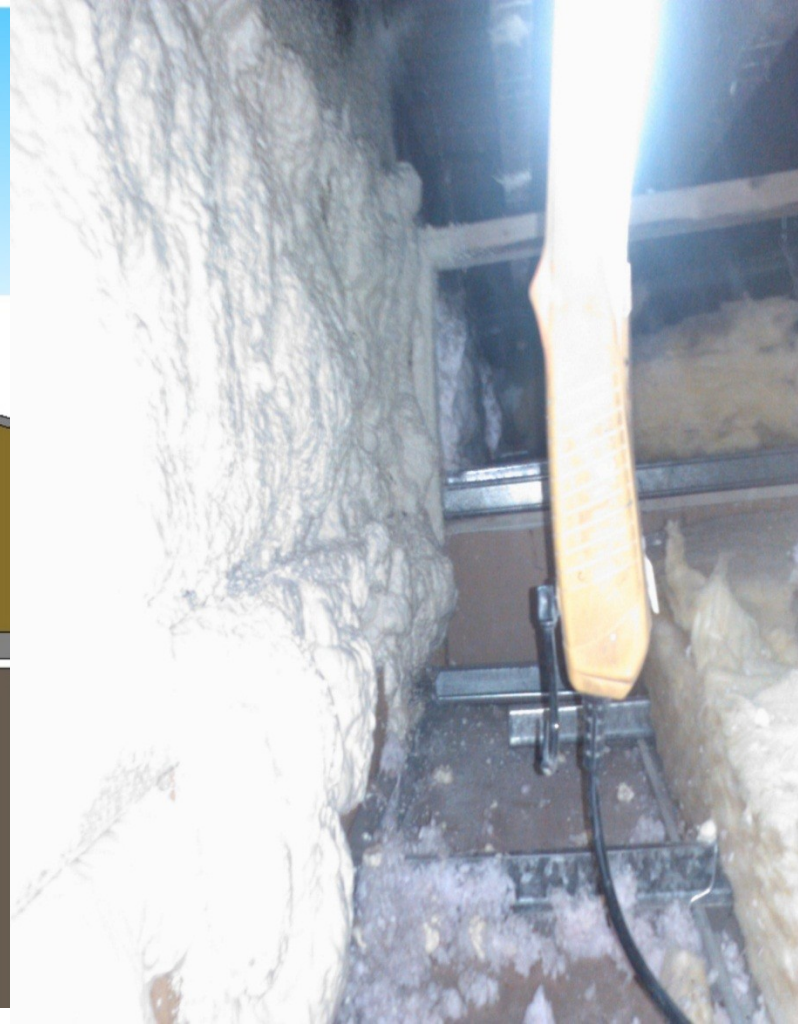
Once in the rim/band joist, spray foam was applied from top to bottom, end to end. (note color change)

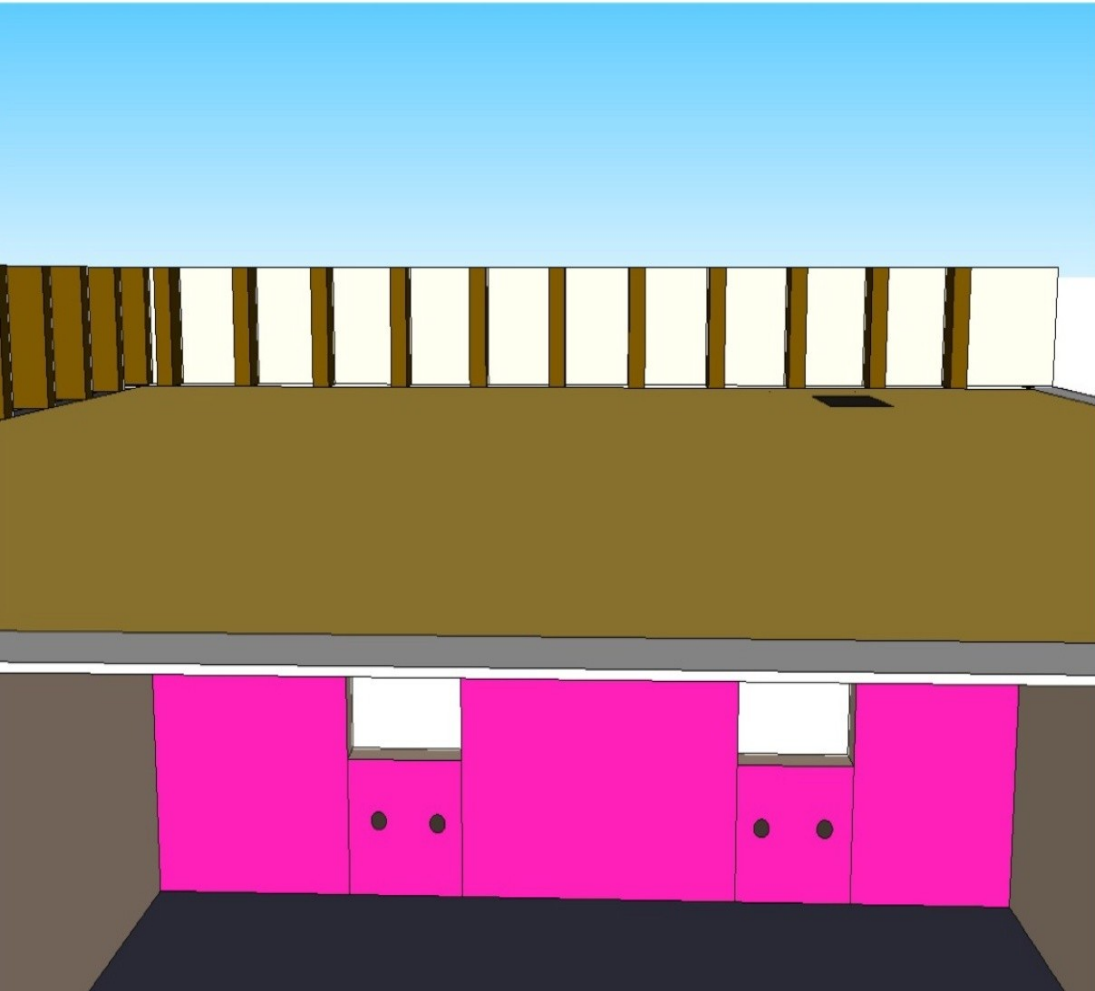
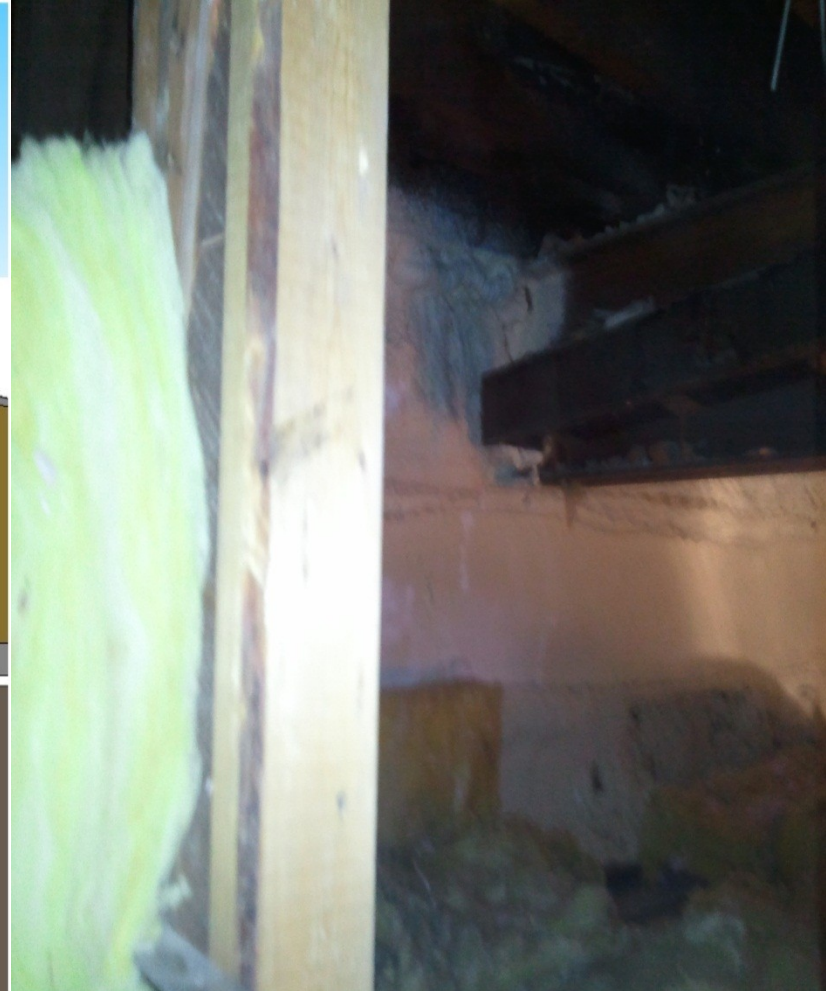
While still in the rim/band joist, after the spray foam application, intumescent fire guard paint was applied over the spray foam (note color change)

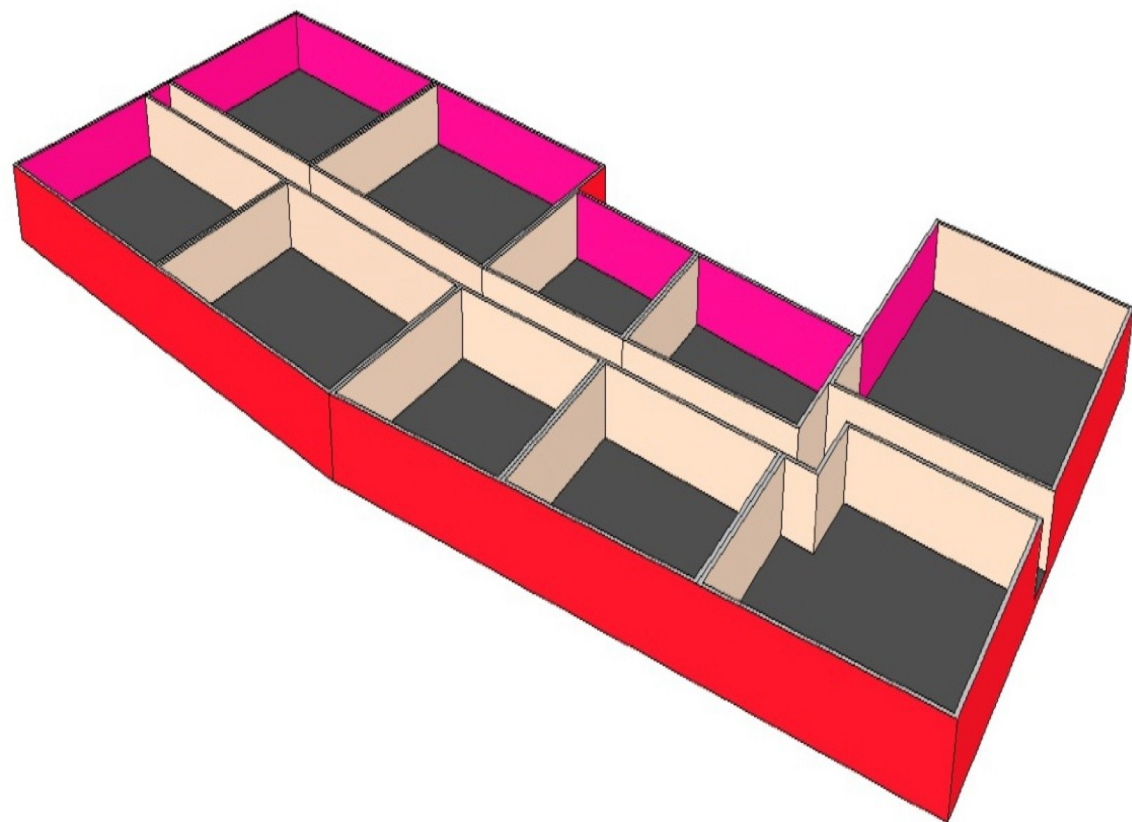
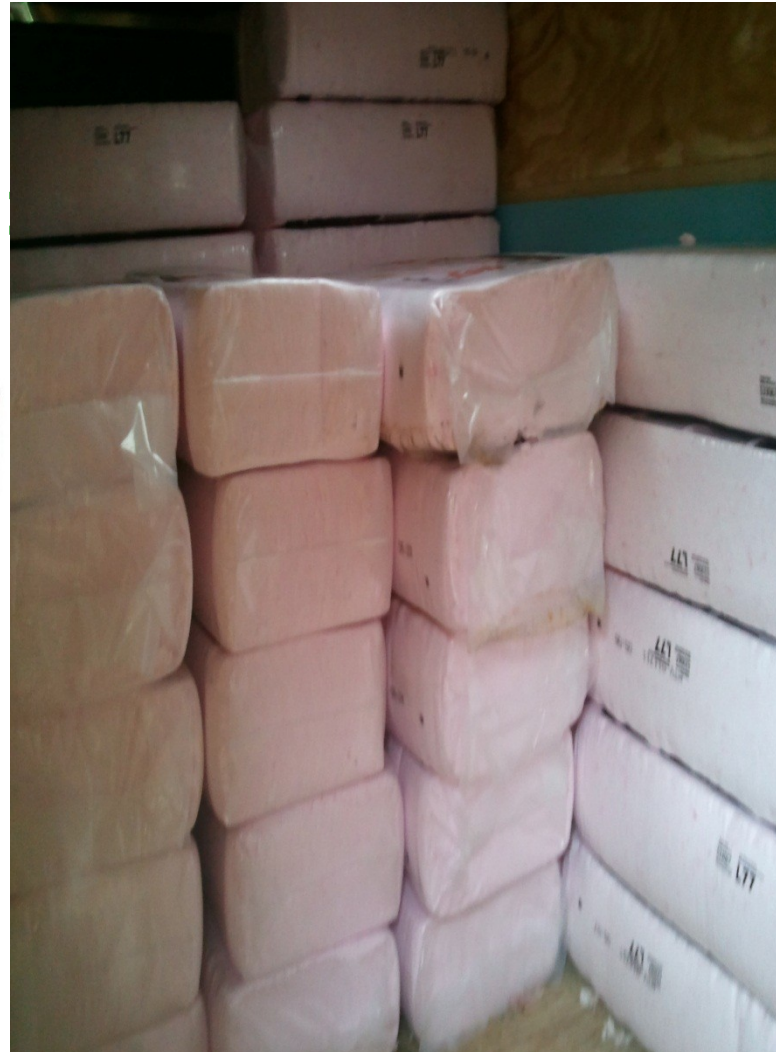
Over 3 tons of blown fiberglass insulation was installed as each apartment received the same remedy around the whole building.

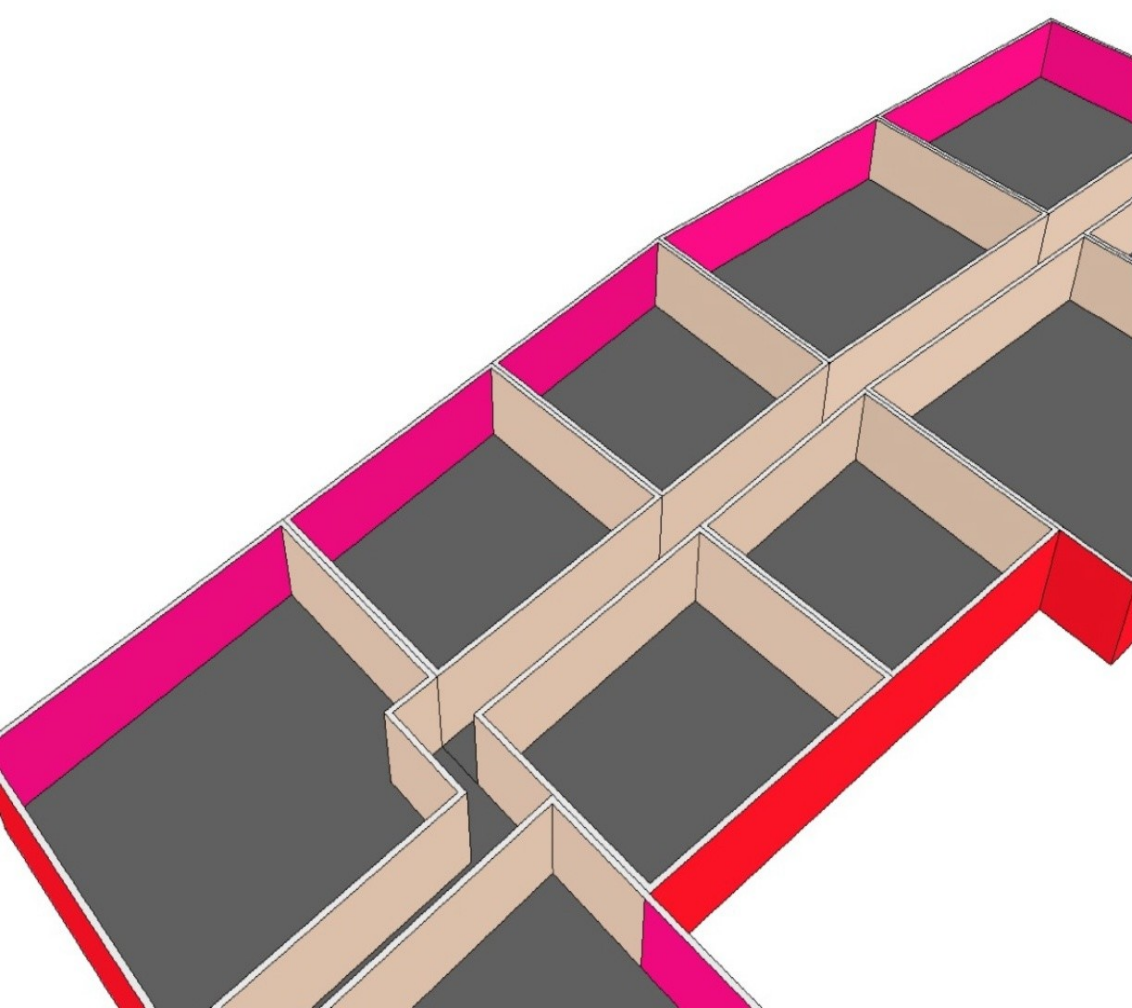
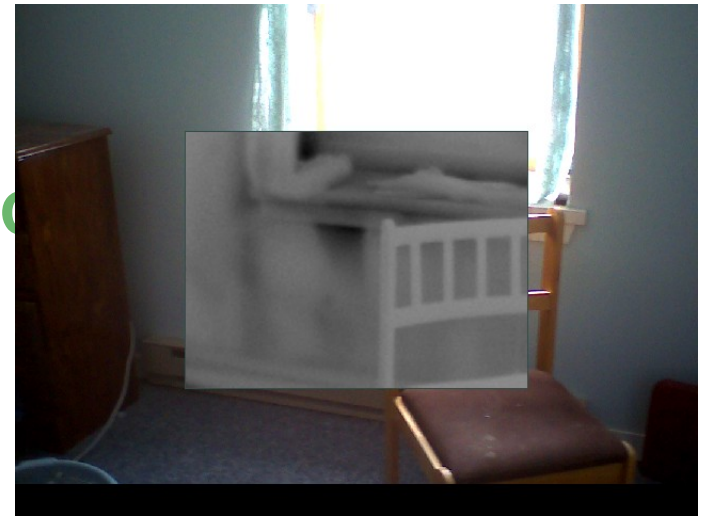
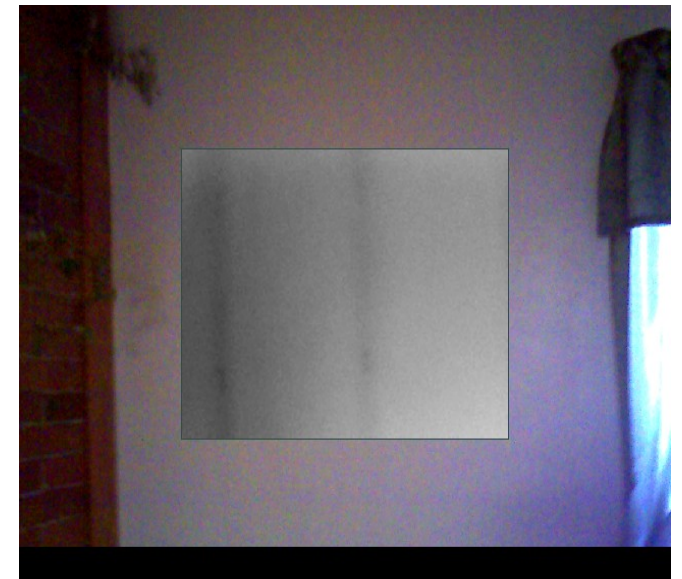
Thermal imaging was used to ensure all cavities were filled.

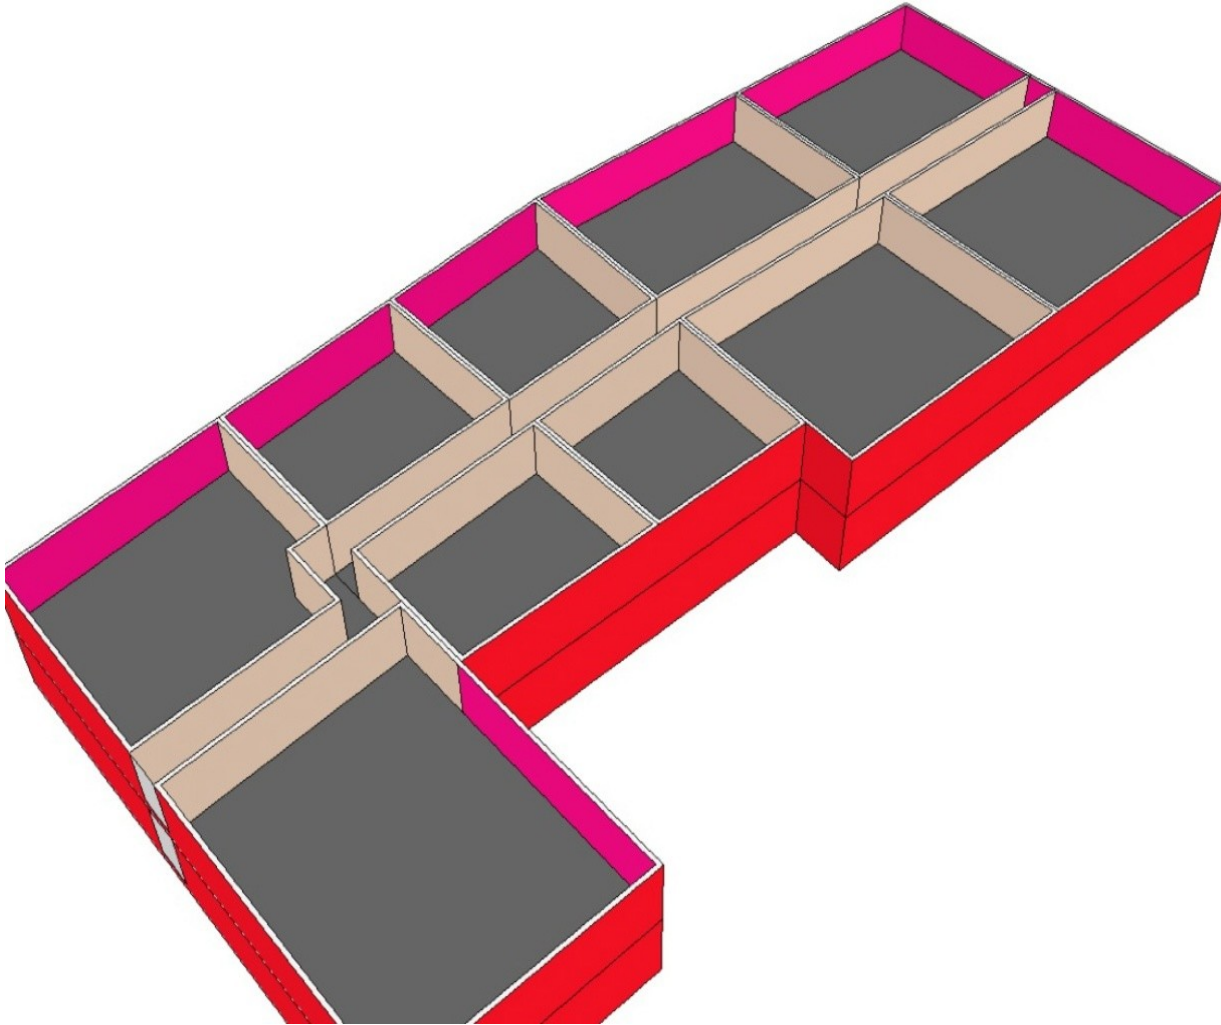
Thermal imaging was also used to air seal as the enveloped closed in.

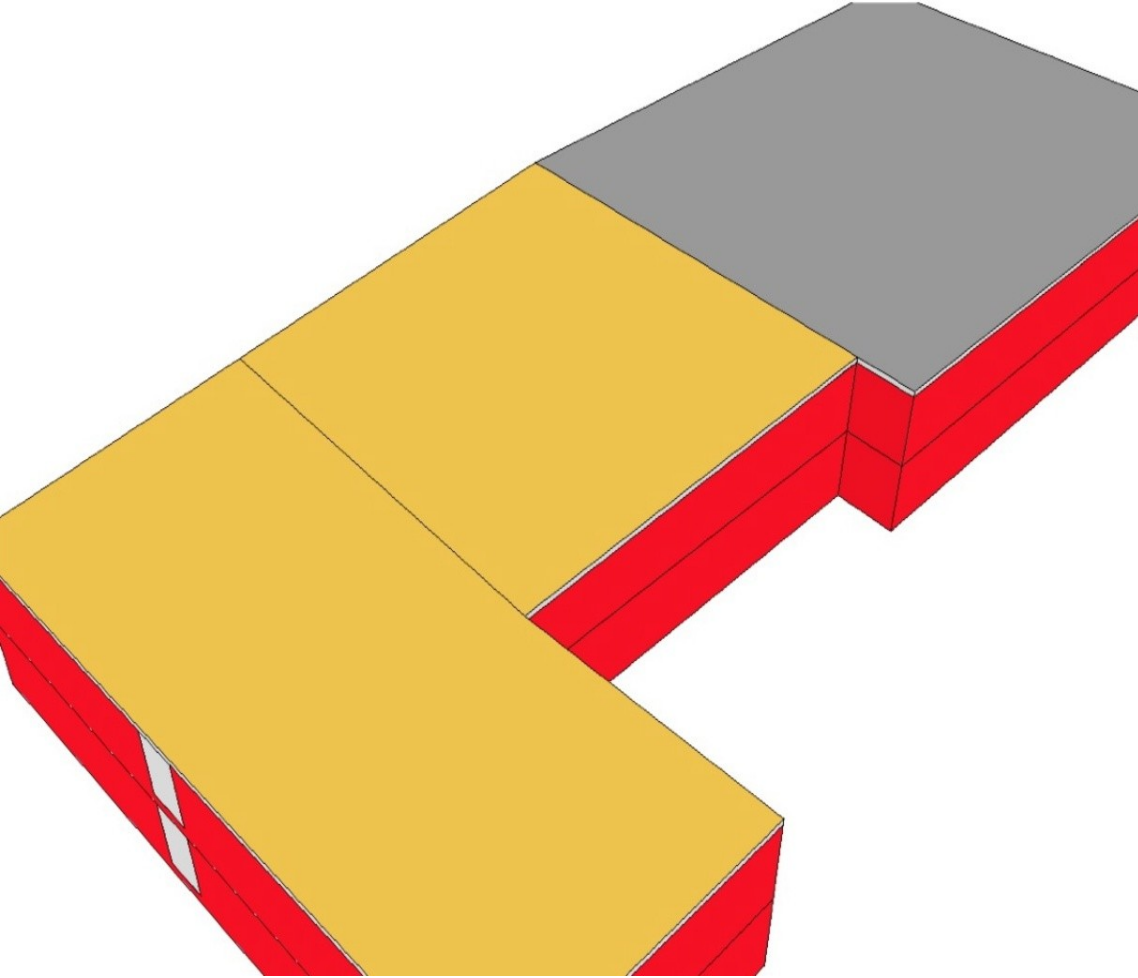
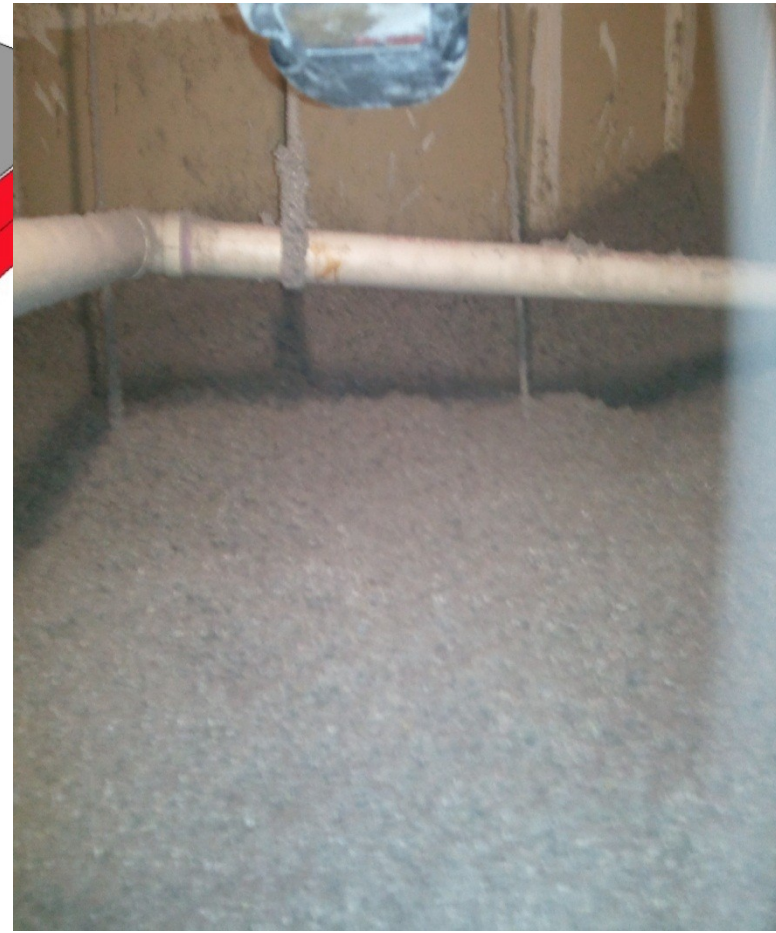
**The attic was insulated with blown cellulose,
one apartment at a time.**
