Case Study
Arbor Dev. 30 Seneca St. Hornell, NY

Building Performance 20 Large Apartments Envelope Common Areas

Building Performance 20 Large Apartments & Common Areas

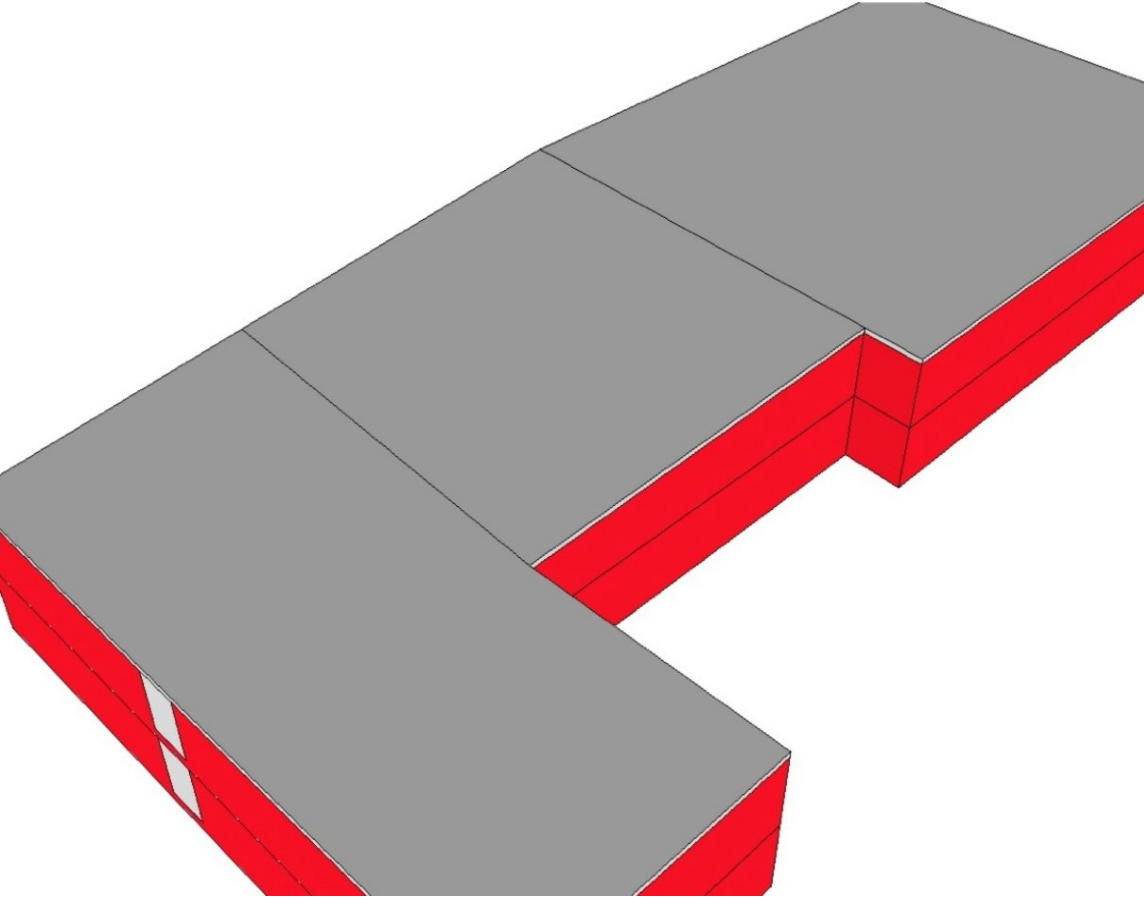
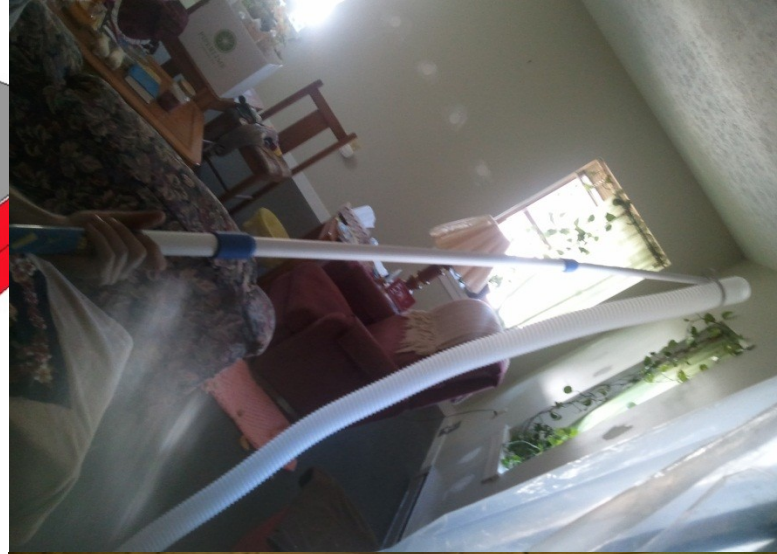
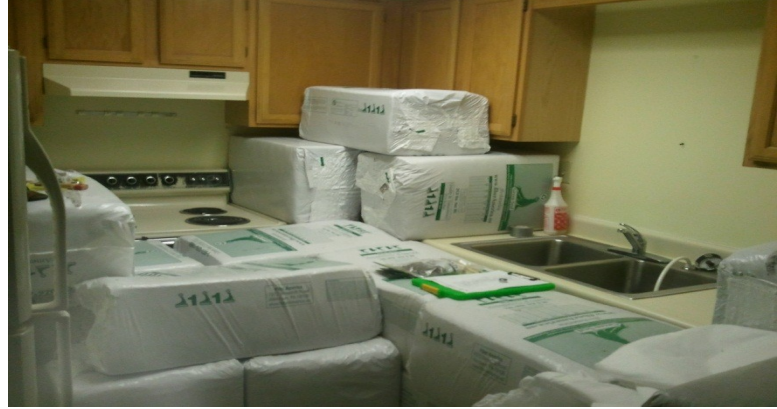
Special tools were used to reach all areas (top right). This was our stuffed storage apartment(bottom right). We went through over 5 tons of cellulose.

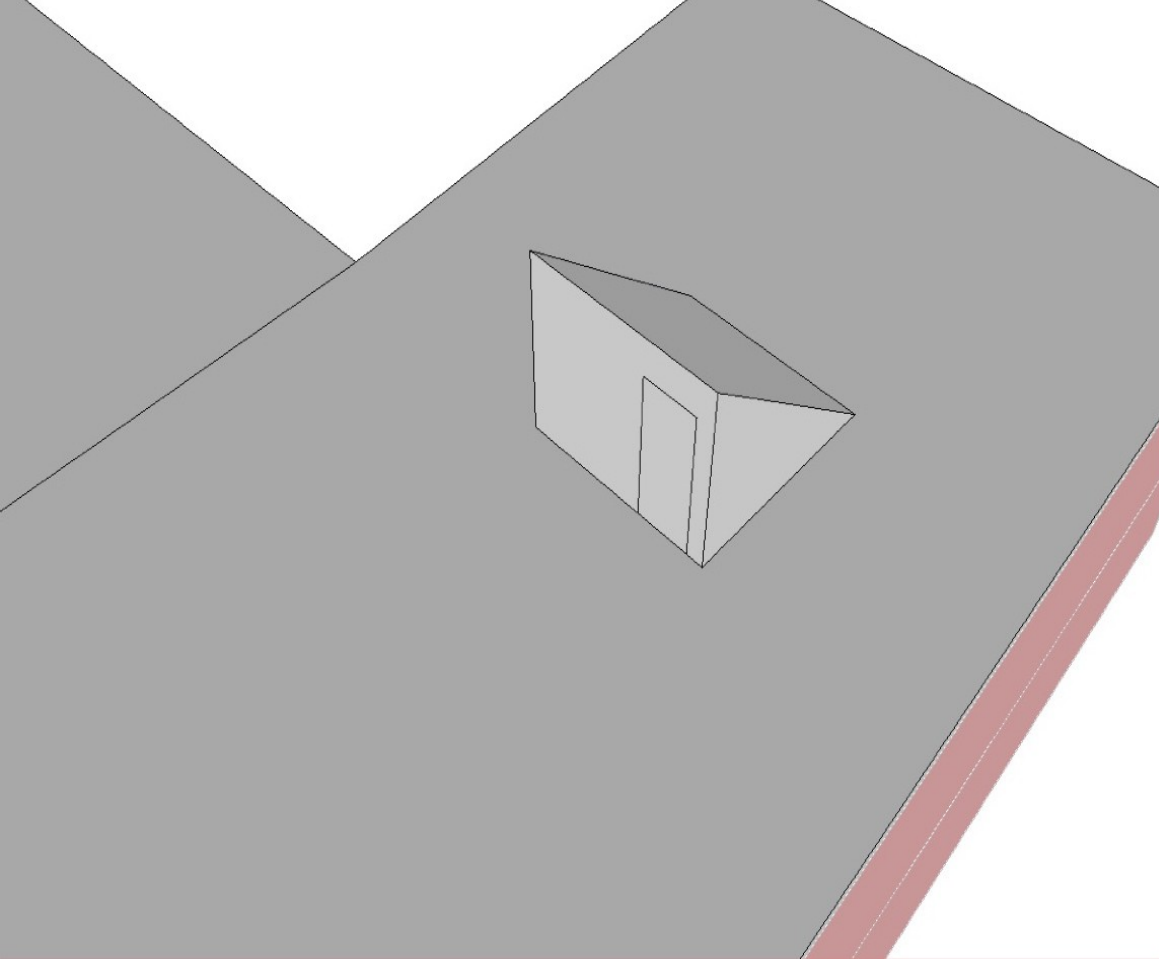
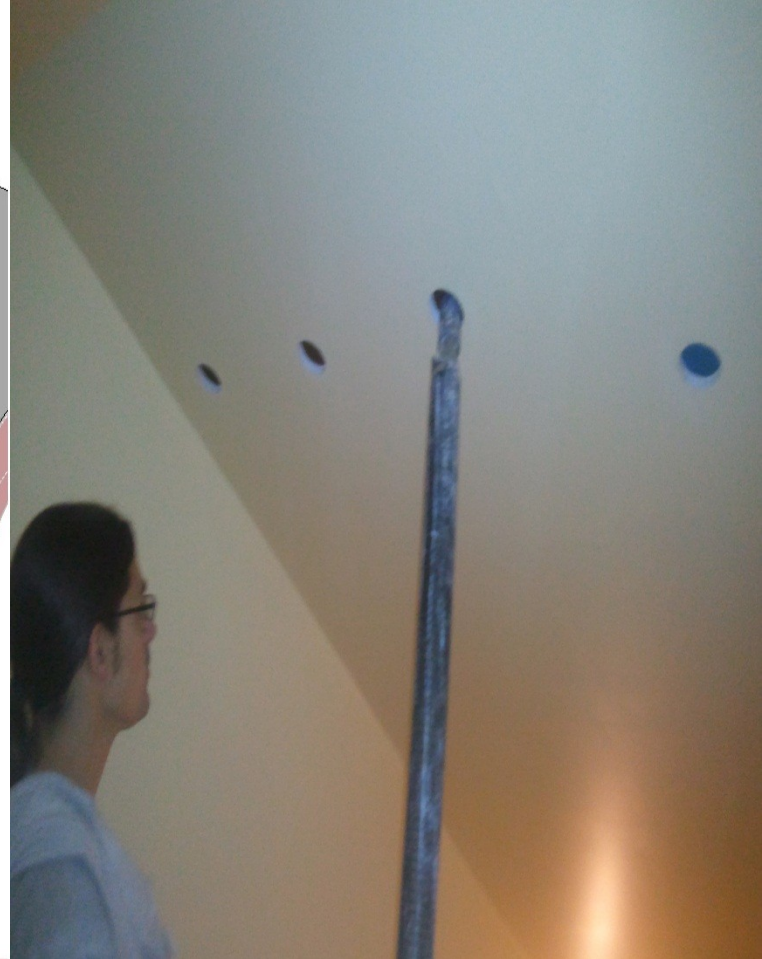
**We didn't leave out these upper stairwells
once we discovered there wasn't ANY
insulation in them!**

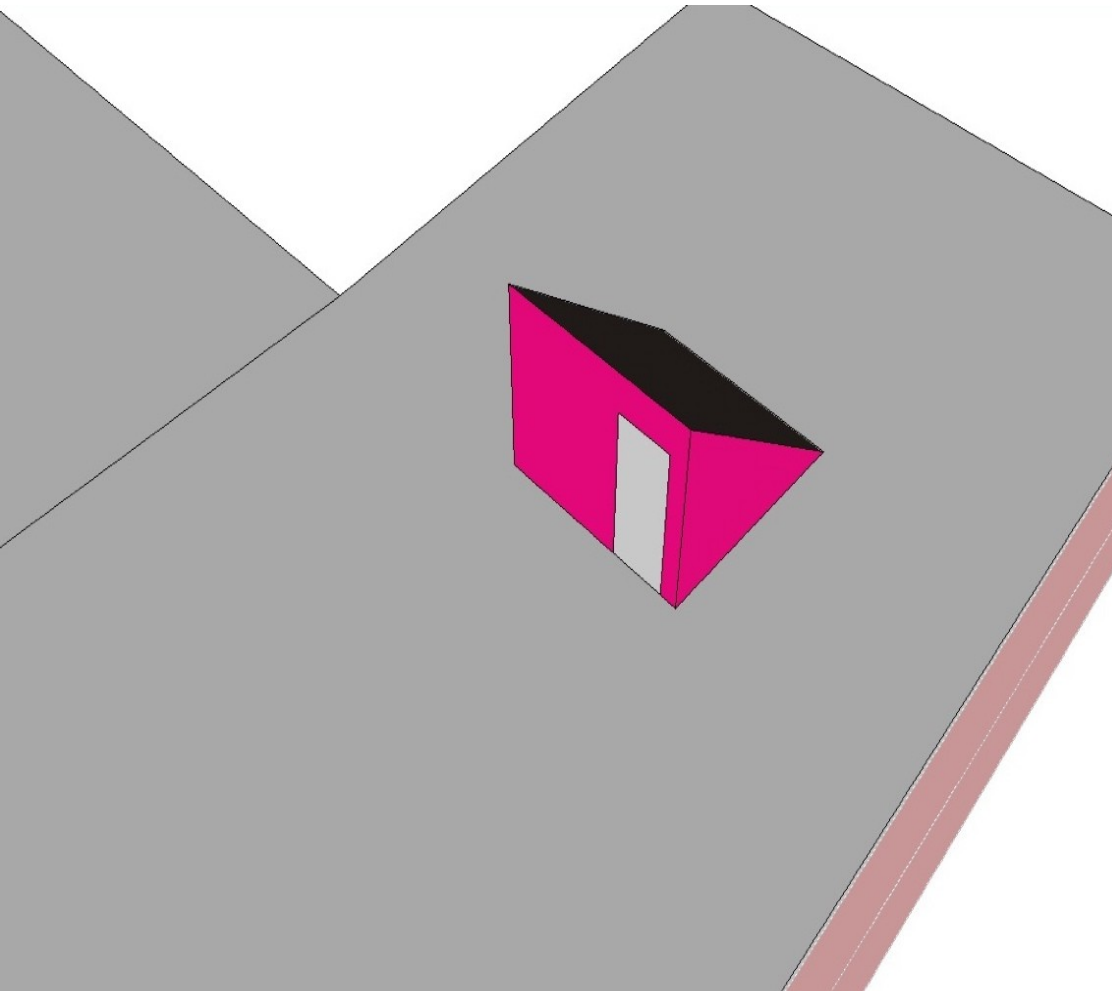
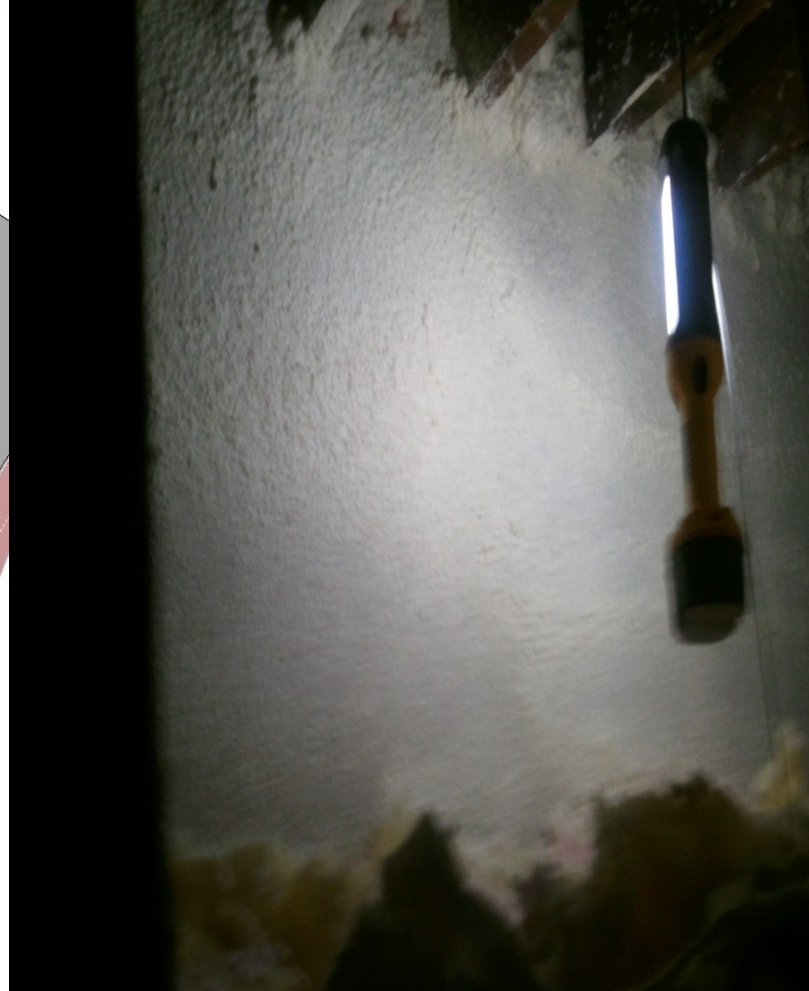
**Some of the upper stairwells were air sealed
& insulated with spray foam from inside.**
